# Manhole Inspection Summary

Manhole # S09YY1021MH

**Inspection** ☐ Is Incomplete Rating: **4) Poor**

**Location** Address: **2503 MANHATTAN AVE**

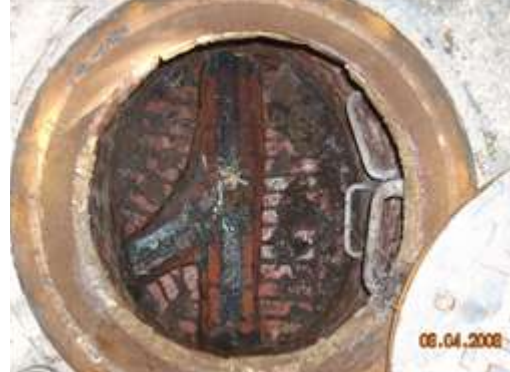
Top View

Corroded steps. Evidence of surcharge - Bench debris. Channel debris.

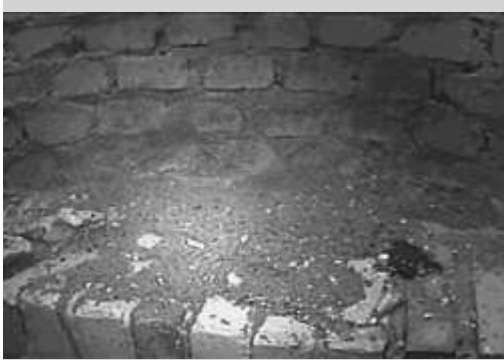
Defect

Barrel deterioration and infiltration. Bench deterioration and debris.

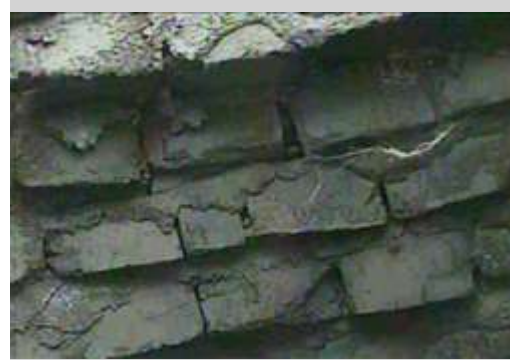
Defect

Corbel deterioration, root intrusion and infiltration.

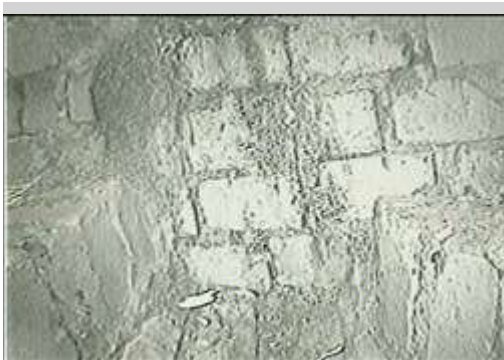
Defect

Barrel root intrusion, deterioration and infiltration. Bench and Channel deterioration.

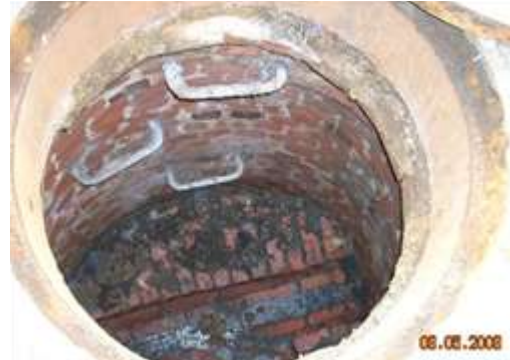
Defect

Frame leaks. Frame offset. Corbel deterioration and infiltration. Barrel infiltration - other side.

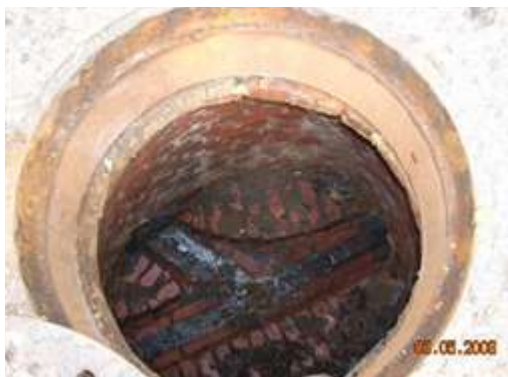
### Defect

Frame leaks. Frame offset. Corbel deterioration and infiltration. Barrel infiltration - other side.

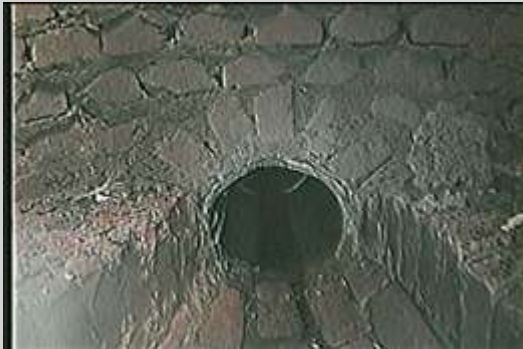
8 in. Circular Gravity Sewer  
Pipe Out @ 12 O'Clock

Barrel deterioration and infiltration. Channel deterioration.

Infiltration: **Evidence** Pipe Seal Cond: **Unknown**

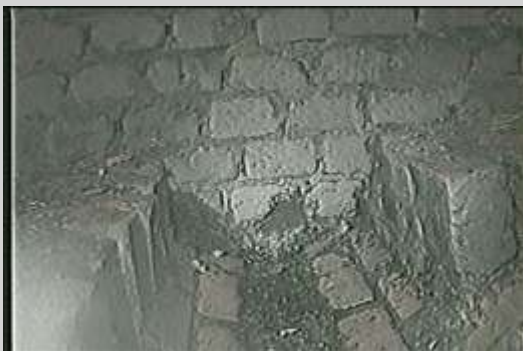
Pipe In @ 6 O'Clock

Connects To: **Stub connection / abandoned**

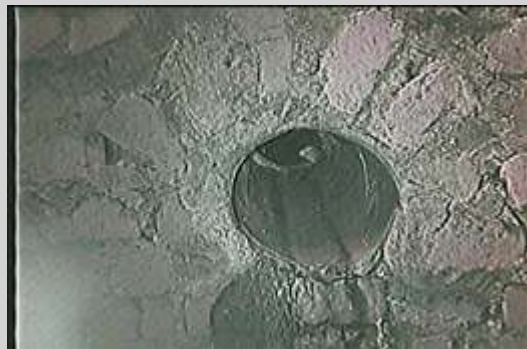
Pipe In @ 8 O'Clock

Infiltration: **Evidence**

Pipe Seal Cond: **Roots**
